MEDIAN BARRIER

Description: After a string of cross-median crashes on limited access highways, DelDOT performed a statewide median barrier assessment for controlled-access highways. DelDOT initiated an effort to install median barrier as a strategy to reduce roadway departures outlined in the Strategic Highway Safety plan. DelDOT currently has installed 77 miles of median barrier on the 112 mile limited access highway network. An additional 35 miles of limited access highways need median barrier coverage. This SOGR sheet is intended to track DelDOT's progress toward achieving 100% coverage of limited access highway medians.

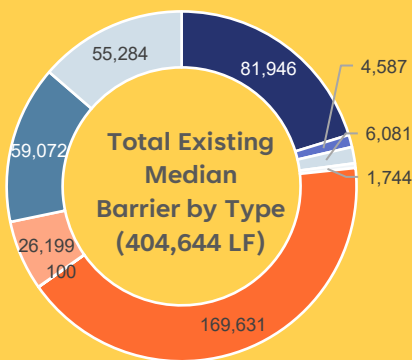
Existing Barrier by Type

The inventory of existing median barrier includes approximately 77 miles (over 404,000 linear feet) of different barrier types. The first set of charts shows the existing median barrier inventory broken out by barrier type and the limited access highway route where barrier is located. The second set of charts identifies the gaps in median barrier and the percentage of each limited access highway route that needs median barrier coverage. All distances are in linear feet.
